# Access Compliance Report Public Rights-of-Way (Curb Ramps)

Main Street: FAIRHAVEN\_AVE Cross Street: PALOMAR\_WAY Location: NW

ADA ID: RPAT211022091816 Ramp Type: Type 4 - Parallel Initial Pass/Fail: Fail Overall Compliance: No Severity Score: 30

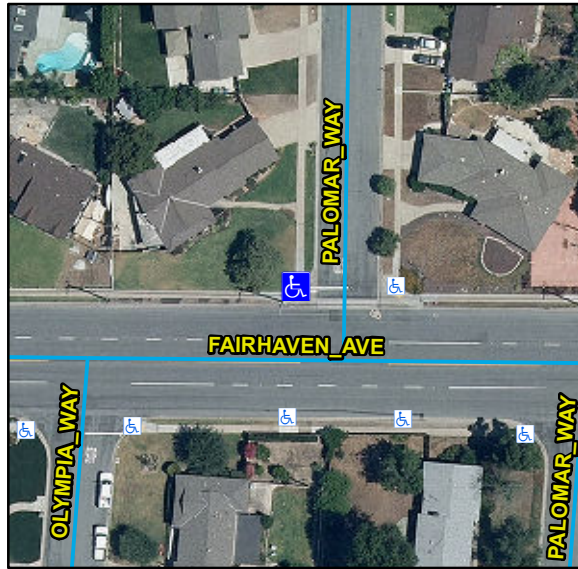
| Compliance | Description | Data | Compliance | Description | Data |
|---|---|---|---|---|---|
| No | Ramp Cross Slope LT (%) | 7.7 | Yes | Ramp Cross Slope RT (%) | 1.8 |

Remove & Replace Curb Ramp With Two New Directional Ramps or Equivalent.

R304.2.2, R304.5.3, STD 1115
