# Access Compliance Report Public Rights-of-Way (Curb Ramps)

Main Street: PALOMAR\_WAY Cross Street: FAIRHAVEN\_AVE Location: NE

ADA ID: RPAT211022092211 Ramp Type: Type 4 - Parallel Initial Pass/Fail: Fail Overall Compliance: No Severity Score: 15

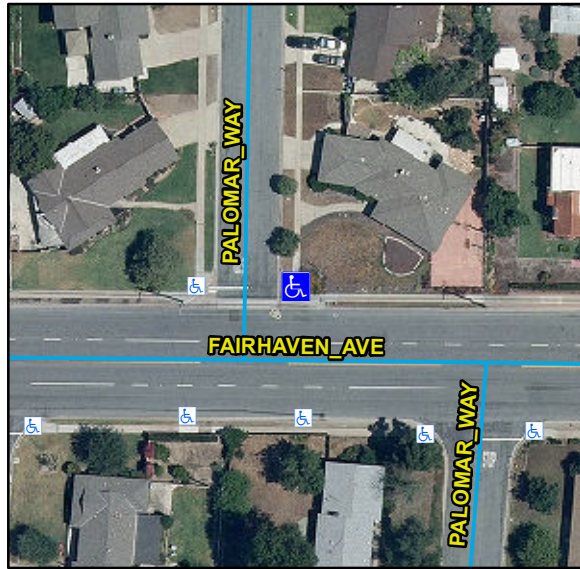
| Compliance | Description | Data | Compliance | Description | Data |
|---|---|---|---|---|---|
| No | Ramp Cross Slope LT (%) | 3.1 | No | Ramp Cross Slope RT (%) | 6.5 |

Remove & Replace Curb Ramp With Two New Directional Ramps or Equivalent.

R304.5.3, STD 1115
