# Access Compliance Report Public Rights-of-Way (Curb Ramps)

Main Street: PALOMAR\_WAY Cross Street: FAIRHAVEN\_AVE Location: SW

ADA ID: RPAT211022092859 Ramp Type: Type 6 - Directional 1 Initial Pass/Fail: Pass Overall Compliance: No Severity Score: 10

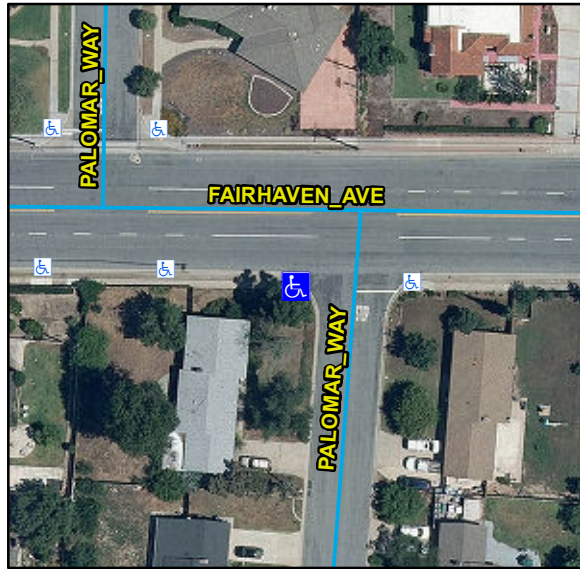
| Compliance | Description | Data | Compliance | Description | Data |
|---|---|---|---|---|---|
| No | Grade Break Cross Slope (%) | 4.1 | N/A | Flare Slope RT (%) | N/A |
| No | Landing Length (in) | 44 | Yes | DWS Length (in) | 77 |
| No | Landing Cross Slope (%) | 2.9 | Yes | DWS Left Offset (in) | 0 |
| No | Gutter Run Slope (%) | 5.9 | | Road Cross Slope (%) | 6.1 |

**Remove & Replace Curb Ramp With Two New Directional Ramps or Equivalent. Remove & Replace Gutter.**

**R304.2.1, R304.5.3, R304.5.4, STD 1115**
