# Access Compliance Report Public Rights-of-Way (Curb Ramps)

Main Street: FAIRHAVEN\_AVE Cross Street: PALOMAR\_WAY Location: SE

ADA ID: RPAT211022093616 Ramp Type: Type 6 - Directional 1 Initial Pass/Fail: Fail Overall Compliance: No Severity Score: 2

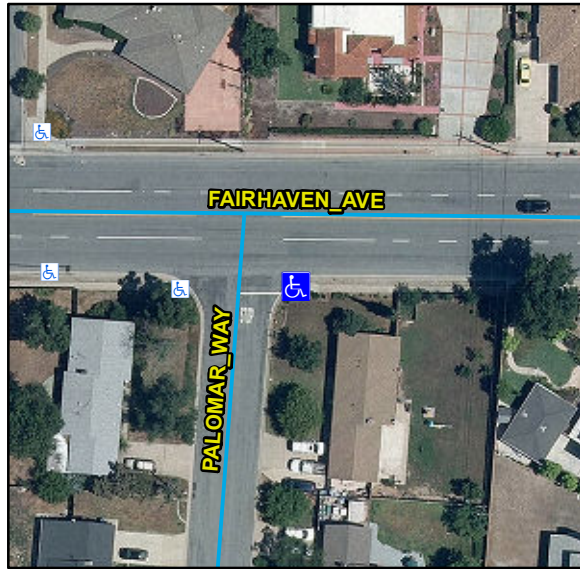
| Compliance | Description | Data | Compliance | Description | Data |
|---|---|---|---|---|---|
| No | Ramp Cross Slope (%) | 2.3 | N/A | Flare Traversable LT | N/A |

Remove & Replace Curb Ramp With Two New Directional Ramps or Equivalent.

R304.5.3, STD 1115
