# Access Compliance Report Public Rights-of-Way (Curb Ramps)

Main Street: DUNAS\_RD Cross Street: FAIRHAVEN\_AVE Location: NE

ADA ID: RPAT211022094231 Ramp Type: Type 1 - Perpendicular Diagonal Initial Pass/Fail: Fail Overall Compliance: No Severity Score: 15

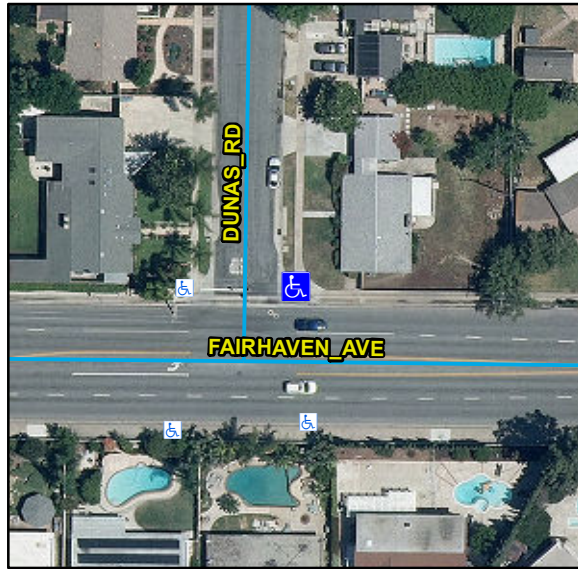
| Compliance | Description | Data | Compliance | Description | Data |
|---|---|---|---|---|---|
| No | Ramp Run Slope (%) | 9.7 | N/A | Flare Slope LT (%) | N/A |

**Remove & Replace Curb Ramp With Two New Directional Ramps or Equivalent.**

**R304.2.2, STD 1115**
