# Access Compliance Report Public Rights-of-Way (Curb Ramps)

| Main Street: FAIRHAVEN_AVE | | Cross Street: DUNAS_RD | | Location: | NW |
| ADA ID: RPAT211022094710 | Ramp Type: Type 3 - Combination 1 | Initial Pass/Fail: Fail | Overall Compliance: No | Severity Score: | 2 |

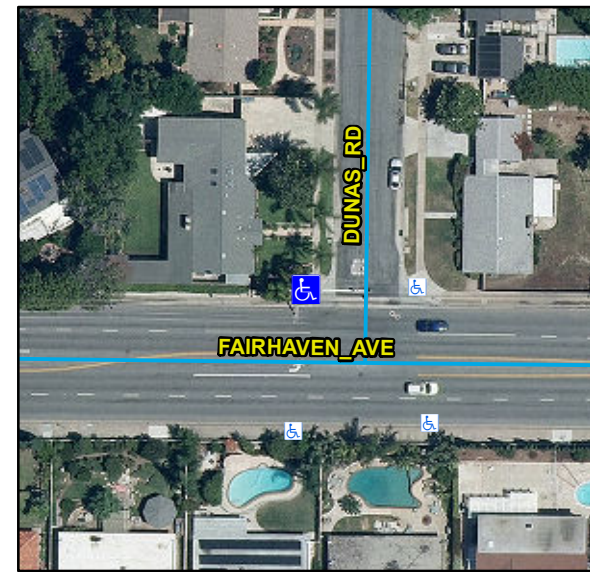
| Compliance | Description | Data | Compliance | Description | Data |
|---|---|---|---|---|---|
| No | Ramp Cross Slope LT (%) | 4.6 | No | Ramp Cross Slope RT (%) | 3.8 |
| No | Ramp Cross Slope (%) | 4.1 | N/A | Flare Traversable LT | N/A |

**Remove & Replace Curb Ramp With Two New Directional Ramps or Equivalent.**

**R304.2.2, R204.3, R304.5.3, STD 1115**

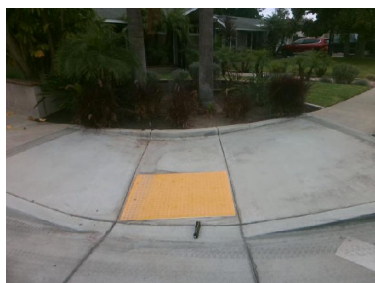
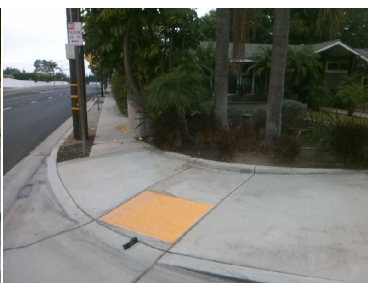
| Compliance | Description | Data | Compliance | Description | Data |
|---|---|---|---|---|---|
| N/A | Ramp Length LT (in) | 93 | N/A | Ramp Length RT (in) | 93 |
| Yes | Ramp Width LT (in) | 93 | Yes | Ramp Width RT (in) | 105 |
| Yes | Ramp Run Slope LT (%) | 6.5 | Yes | Ramp Run Slope RT (%) | 8.2 |
| N/A | Gutter Ponding | N/A | No | Curb Slope | 14.6 |
| Yes | Overall Surface Condition: Acceptable | | | | |
