# Access Compliance Report Public Rights-of-Way (Curb Ramps)

| Main Street: PROSPECT_ST | | Cross Street: FAIRHAVEN_AVE | | Location: | NE |
| ADA ID: RPAT211022104521 | Ramp Type: Type 4 - Parallel | Initial Pass/Fail: Fail | Overall Compliance: No | Severity Score: | 32 |

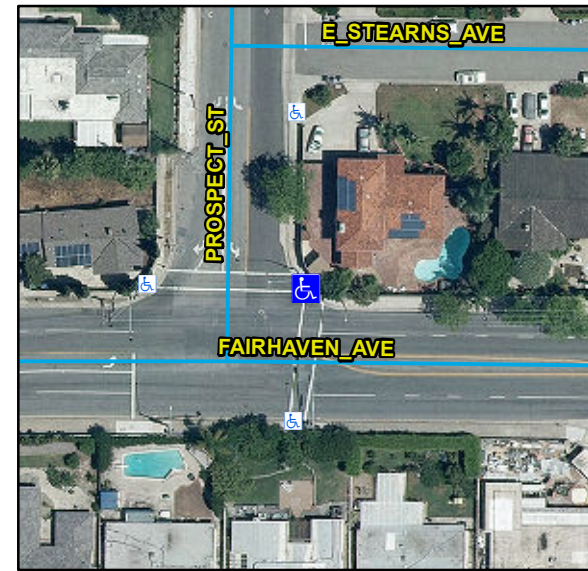
| Compliance | Description | Data | Compliance | Description | Data |
|---|---|---|---|---|---|
| No | Ramp Run Slope LT (%) | 14.2 | No | Ramp Run Slope RT (%) | 10.5 |
| No | Ramp Cross Slope LT (%) | 3.3 | Yes | Ramp Cross Slope RT (%) | 0.7 |

**Remove & Replace Curb Ramp With Two New Directional Ramps or Equivalent.**

**R304.3.2, R304.5.3, STD 1115**

Total Cost: \$ 4000
