# Access Compliance Report Public Rights-of-Way (Curb Ramps)

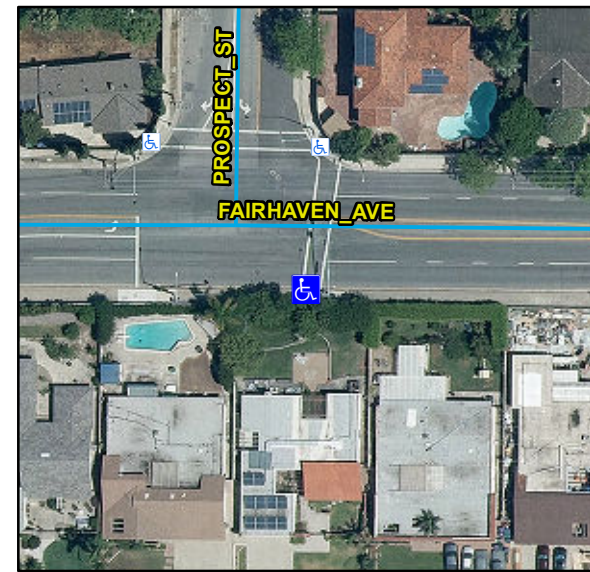
| Main Street: FAIRHAVEN_AVE | | Cross Street: PROSPECT_ST | | Location: | SE |
| ADA ID: RPAT211022105222 | Ramp Type:Type 1 - Perpendicular | Initial Pass/Fail: Fail | Overall Compliance: No | Severity Score: | 30 |

| Compliance | Description | Data | Compliance | Description | Data |
|---|---|---|---|---|---|
| No | Ramp Run Slope (%) | 15.1 | N/A | Flare Slope LT (%) | N/A |

Possible Solutions:

Remove & Replace Entire Ramp.

R304.2.2, R204.3, STD 1115

Total Cost: \$ 3080
