# Access Compliance Report Public Rights-of-Way (Curb Ramps)

Main Street: E\_ROMELLE\_AVE Cross Street: PROSPECT\_ST Location: SE

ADA ID: RPAT211022125523 Ramp Type: Type 1 - Perpendicular Diagonal Initial Pass/Fail: Pass Overall Compliance: No Severity Score: 4

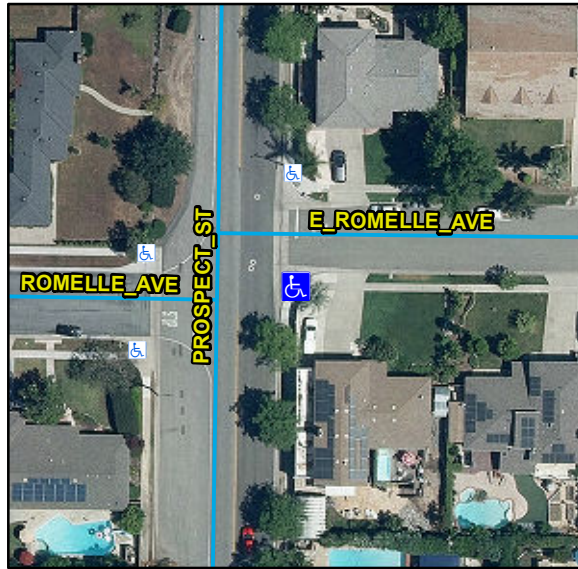
## Field Measurements/Component Compliance

Possible Solutions:

Remove & Replace Landing.

OC Std/PROW:

R304.2.1, STD 1115
