# Access Compliance Report Public Rights-of-Way (Curb Ramps)

Main Street: WHEELER\_PL Cross Street: E\_LARKSTONE\_DR Location: SW

ADA ID: RPAT211022131814 Ramp Type: Type 1 - Perpendicular Diagonal Initial Pass/Fail: Fail Overall Compliance: No Severity Score: 20

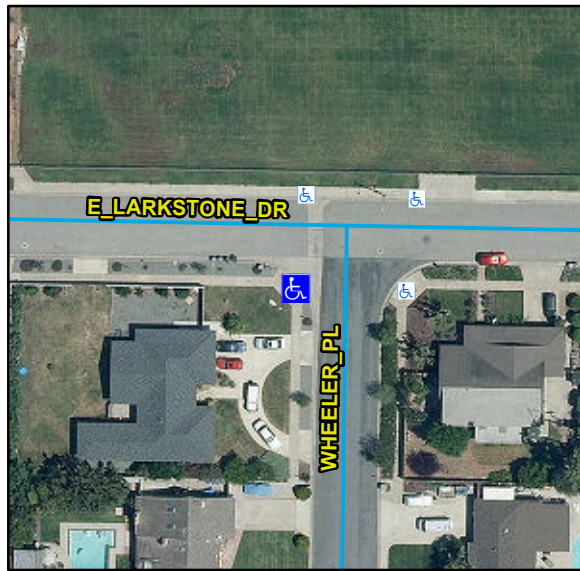
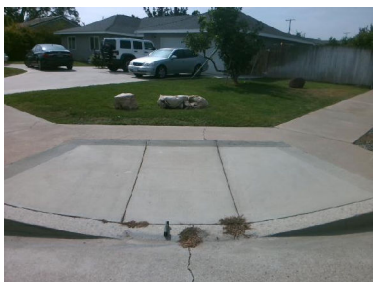
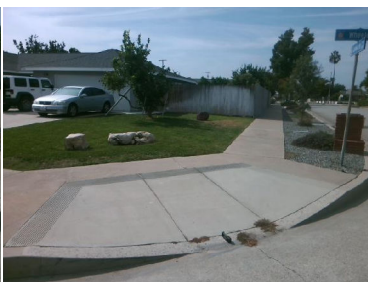
| Compliance | Description | Data | Compliance | Description | Data |
|---|---|---|---|---|---|
| No | Ramp Width (in) | 46 | | | N/A |
| No | Ramp Run Slope (%) | 12 | N/A | Flare Slope LT (%) | N/A |

Remove & Replace Curb Ramp With Two New Directional Ramps or Equivalent.

R304.2.2, R304.5.1, STD 1115
