# Access Compliance Report Public Rights-of-Way (Curb Ramps)

Main Street: E\_LARKSTONE\_DR Cross Street: WHEELER\_PL Location: SE

ADA ID: RPAT211022132121 Ramp Type: Type 1 - Perpendicular Diagonal Initial Pass/Fail: Fail Overall Compliance: No Severity Score: 19

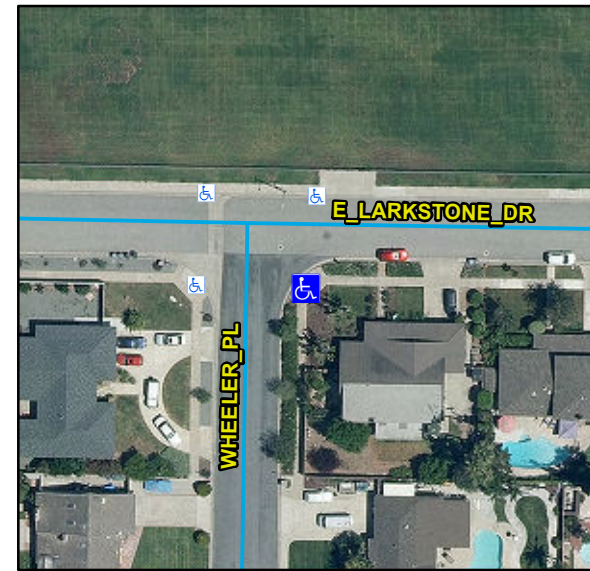
| Compliance | Description | Data | Compliance | Description | Data |
|---|---|---|---|---|---|
| No | Ramp Width (in) | 44 | | | N/A |
| No | Ramp Run Slope (%) | 11.6 | N/A | Flare Slope LT (%) | N/A |

Remove & Replace Curb Ramp With Two New Directional Ramps or Equivalent.
