# Access Compliance Report Public Rights-of-Way (Curb Ramps)

Main Street: LARKSTONE\_DR Cross Street: MALENA\_DR Location: SE

ADA ID: RPAT211022132924 Ramp Type: Type 1 - Perpendicular Diagonal Initial Pass/Fail: Fail Overall Compliance: No Severity Score: 5

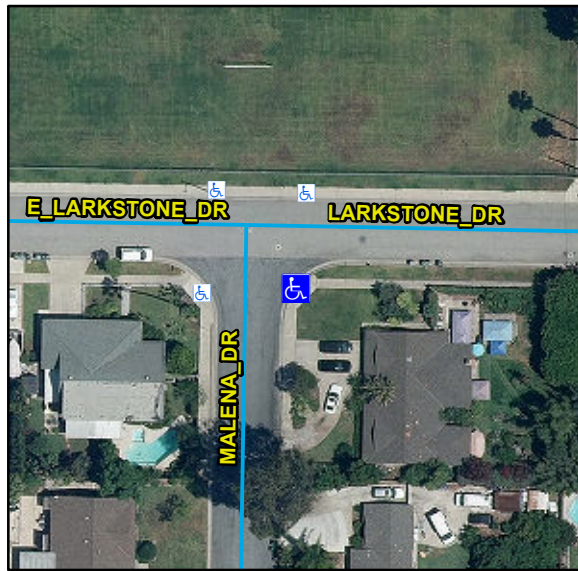
| Compliance | Description | Data | Compliance | Description | Data |
|---|---|---|---|---|---|
| No | Ramp Width (in) | 47 | | | N/A |
| No | Ramp Cross Slope (%) | 3.4 | N/A | Flare Traversable LT | N/A |

Remove & Replace Curb Ramp With Two New Directional Ramps or Equivalent.

R304.2.2, R304.5.1, R304.5.3, STD 1115
