# Access Compliance Report Public Rights-of-Way (Curb Ramps)

Main Street: WHITNEY\_DR Cross Street: PROSPECT\_AVE Location: SE

ADA ID: RPAT211022142905 Ramp Type: Type 1 - Perpendicular Diagonal Initial Pass/Fail: Fail Overall Compliance: No Severity Score: 4

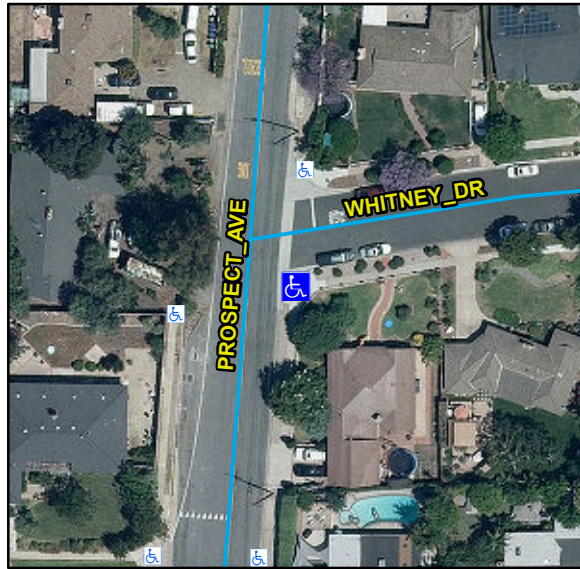
| Compliance | Description | Data | Compliance | Description | Data |
|---|---|---|---|---|---|
| No | Ramp Width (in) | 47 | | | N/A |

Remove & Replace Curb Ramp With Two New Directional Ramps or Equivalent.

R304.2.2, R304.5.1, STD 1115
