# Access Compliance Report Public Rights-of-Way (Curb Ramps)

Main Street: PROSPECT\_AVE Cross Street: WHITNEY\_DR Location: NE

ADA ID: RPAT211022143050 Ramp Type: Type 1 - Perpendicular Diagonal Initial Pass/Fail: Pass Overall Compliance: No Severity Score: 0

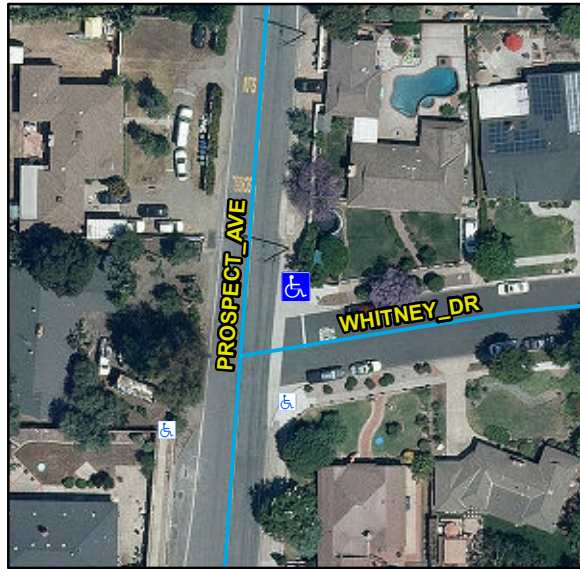
| Compliance | Description | Data | Compliance | Description | Data |
|---|---|---|---|---|---|
| Yes | Gutter Ponding | No | No | Curb Slope | 12 |

Remove & Replace Curb Ramp With Two New Directional Ramps or Equivalent.

R304.2.2, R304.2.1, STD 1115

Total Cost: \$ 6160
