# Access Compliance Report Public Rights-of-Way (Curb Ramps)

Main Street: RAINIER\_DR Cross Street: PROSPECT\_AVE Location: NW

ADA ID: RPAT211022143508 Ramp Type: Type 1 - Perpendicular Diagonal Initial Pass/Fail: Pass Overall Compliance: No Severity Score: 14

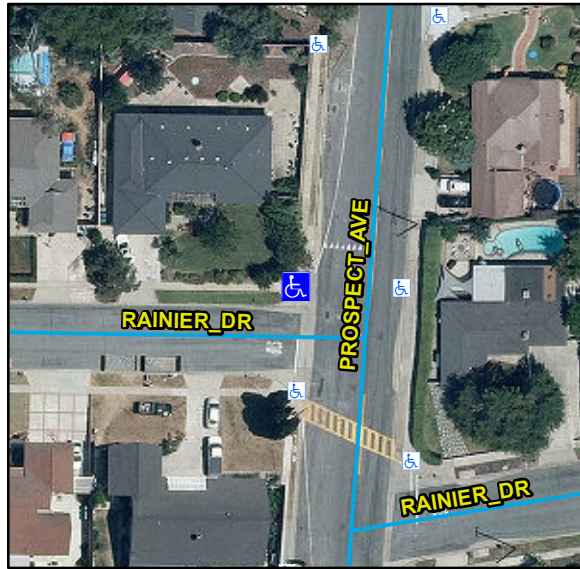
| Compliance | Description | Data | Compliance | Description | Data |
|---|---|---|---|---|---|
| Yes | Landing Cross Slope (%) | 0.6 | No | DWS Provided | No |
| Yes | Overall Surface Condition: Acceptable | | Yes | Perp Joint Present | Yes |

Remove & Replace Curb Ramp With Two New Directional Ramps or Equivalent.

R304.2.1, R305, STD 1115
