# Access Compliance Report Public Rights-of-Way (Curb Ramps)

Main Street: PROSPECT\_AVE Cross Street: RAINIER\_DR Location: W

ADA ID: RPAT211022143832 Ramp Type: Type 1 - Perpendicular Diagonal Initial Pass/Fail: Fail Overall Compliance: No Severity Score: 19

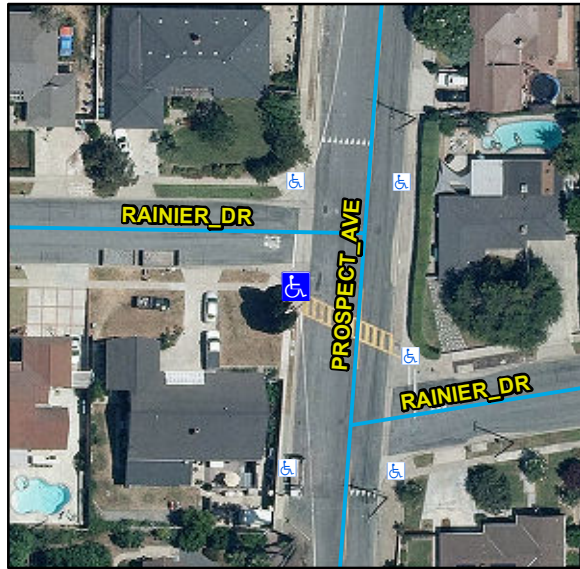
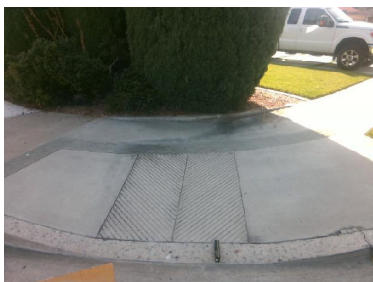
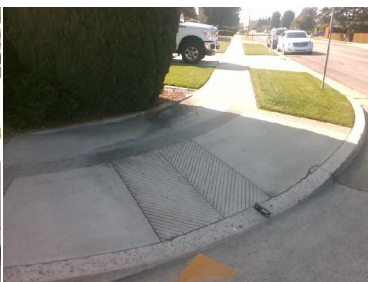
| Compliance | Description | Data | Compliance | Description | Data |
|---|---|---|---|---|---|
| No | Ramp Width (in) | 47 | | | N/A |
| No | Ramp Run Slope (%) | 8.6 | N/A | Flare Slope LT (%) | N/A |

Remove & Replace Curb Ramp With Two New Directional Ramps or Equivalent. Restripe Crosswalk.

R304.2.2, R304.5.1, STD 1115
