# Access Compliance Report Public Rights-of-Way (Curb Ramps)

Main Street: PROSPECT\_AVE Cross Street: RAINIER\_DR Location: NE

ADA ID: RPAT211022144123 Ramp Type: Type 1 - Perpendicular Diagonal Initial Pass/Fail: Pass Overall Compliance: No Severity Score: 10

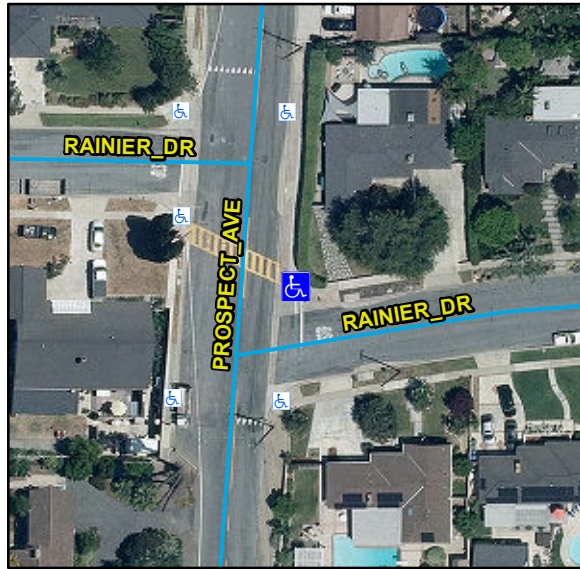
| Compliance | Description | Data | Compliance | Description | Data |
|---|---|---|---|---|---|
| No | Landing Run Slope (%) | 2.1 | N/A | Flare Traversable RT | Yes |
| Yes | Landing Cross Slope (%) | 0.2 | No | DWS Provided | No |
| No | Ramp Inside Crosswalk 1 | No | Yes | Ramp Inside Crosswalk 2 | N/A |

Remove & Replace Curb Ramp With Two New Directional Ramps or Equivalent. Restripe Crosswalk.

R304.2.1, R304.2.2-Perp, R304.3.2-Para, R305, R207.1, STD 1115

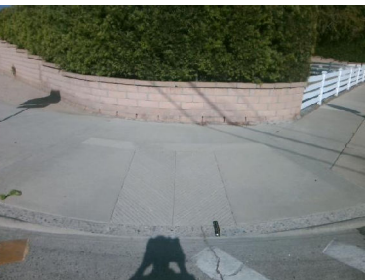
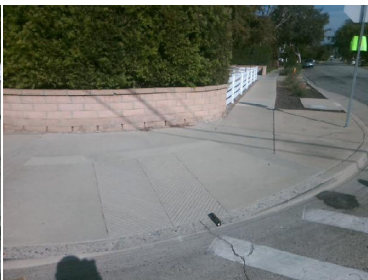
| Compliance | Description | Data | Compliance | Description | Data |
|---|---|---|---|---|---|
| Yes | Overall Surface Condition: Acceptable | | Yes | Perp Joint Present | Yes |
