# Access Compliance Report Public Rights-of-Way (Curb Ramps)

| Main Street: RAINIER_DR | | Cross Street: PROSPECT_AVE | | Location: | SE |
| ADA ID: RPAT211022144424 | Ramp Type:Type 1 - Perpendicular Diagonal Initial Pass/Fail: Fail | | Overall Compliance: No | Severity Score: | 15 |

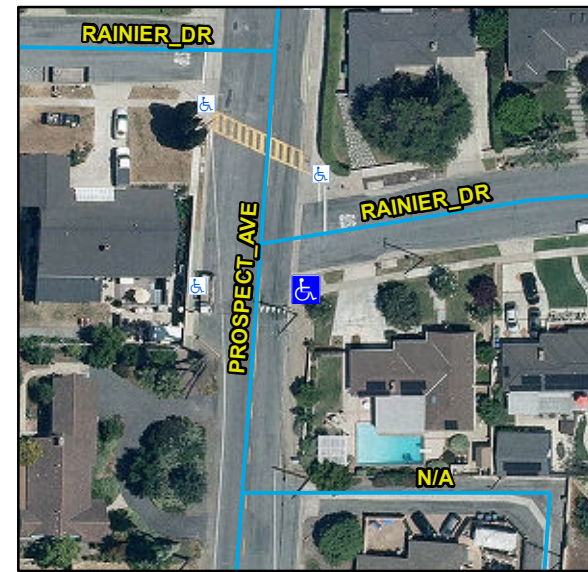
| Compliance | Description | Data | Compliance | Description | Data |
|---|---|---|---|---|---|
| No | Ramp Run Slope (%) | 9.8 | N/A | Flare Slope LT (%) | N/A |

**Remove & Replace Curb Ramp With Two New Directional Ramps or Equivalent.**

**R304.2.2, STD 1115**

Total Cost: \$ 6160
