# Access Compliance Report Public Rights-of-Way (Curb Ramps)

Main Street: RAINIER\_DR Cross Street: SHASTA\_WAY Location: NW

ADA ID: RPAT211022144959 Ramp Type: Type 1 - Perpendicular Diagonal Initial Pass/Fail: Pass Overall Compliance: No Severity Score: 4

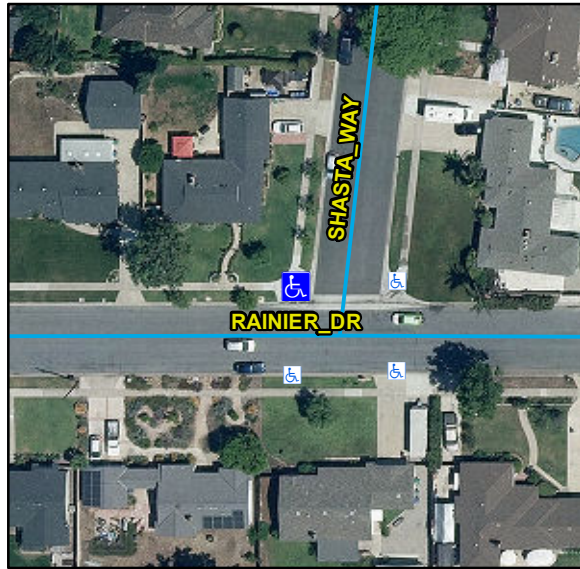
| Compliance | Description | Data | Compliance | Description | Data |
|---|---|---|---|---|---|
| N/A | Landing Length (in) | 45 | | | Sloped |

Remove & Replace Landing.

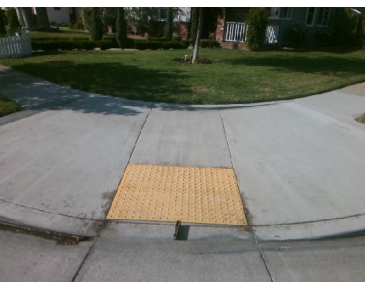
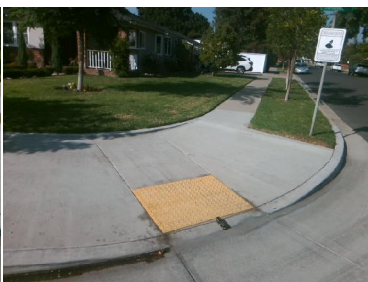
| Compliance | Description | Data | Compliance | Description | Data |
|---|---|---|---|---|---|
| Yes | Overall Surface Condition: Acceptable | | Yes | Perp Joint Present | Yes |
