# Access Compliance Report Public Rights-of-Way (Curb Ramps)

Main Street: RAINIER\_DR Cross Street: BOW\_PL Location: NW

ADA ID: RPAT211022151104 Ramp Type: Type 1 - Perpendicular Diagonal Initial Pass/Fail: Pass Overall Compliance: No Severity Score: 22

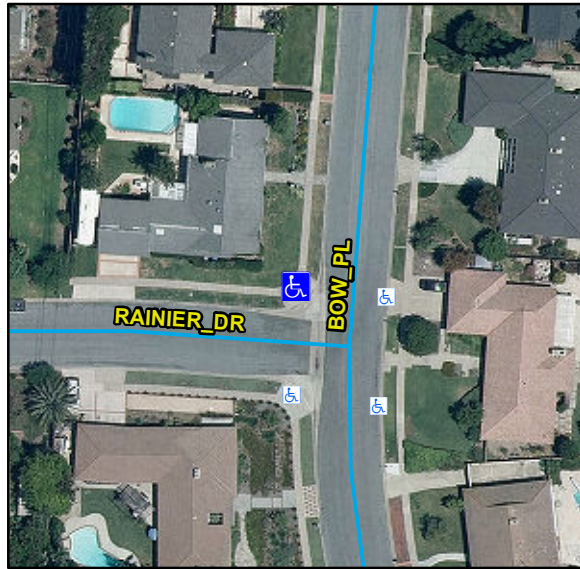
| Compliance | Description | Data | Compliance | Description | Data |
|---|---|---|---|---|---|
| No | Landing Width (in) | N/A | N/A | Flare Slope RT (%) | 4.1 |
| No | Landing Run Slope (%) | N/A | N/A | Flare Traversable RT | No |
| No | Landing Cross Slope (%) | N/A | No | DWS Provided | No |
| Yes | Gutter Ponding | No | No | Curb Slope | 7.8 |

Remove & Replace Curb Ramp With Two New Directional Ramps or Equivalent.
