# Access Compliance Report Public Rights-of-Way (Curb Ramps)

Main Street: BOW\_PL Cross Street: RAINIER\_DR Location: SW

ADA ID: RPAT211022151343 Ramp Type: Type 1 - Perpendicular Diagonal Initial Pass/Fail: Pass Overall Compliance: No Severity Score: 20

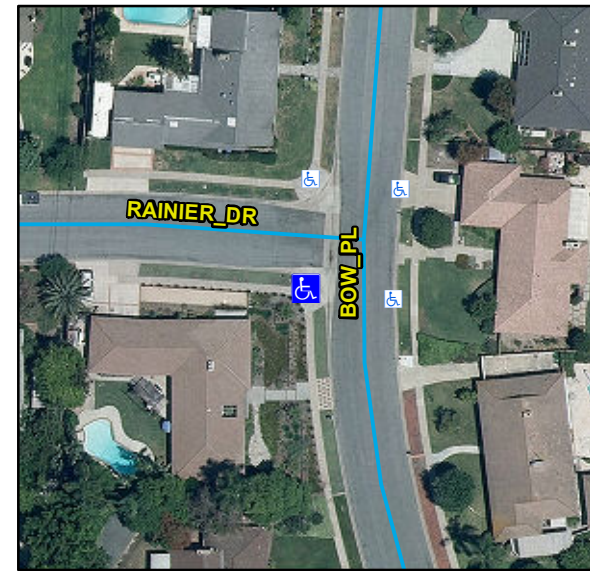
R304.2.2, R204.3, R304.2.1, R304.2.2-Perp, R304.3.2-Para, R304.5.3, R305, STD 1115

Remove & Replace Curb Ramp With Two New Directional Ramps or Equivalent.
