# Access Compliance Report Public Rights-of-Way (Curb Ramps)

Main Street: BOW\_PL Cross Street: BOW\_PL Location: NW

ADA ID: RPAT211022151722 Ramp Type: Type 1 - Perpendicular Diagonal Initial Pass/Fail: Fail Overall Compliance: No Severity Score: 2

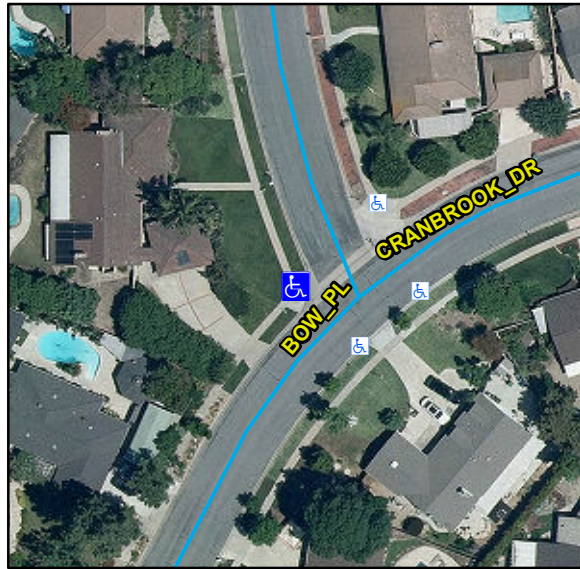
| Compliance | Description | Data | Compliance | Description | Data |
|---|---|---|---|---|---|
| No | Ramp Cross Slope (%) | 3.5 | N/A | Flare Traversable LT | N/A |

Remove & Replace Curb Ramp With Two New Directional Ramps or Equivalent.
