# Access Compliance Report Public Rights-of-Way (Curb Ramps)

Main Street: BOW\_PL Cross Street: CRANBROOK\_DR Location: NE

ADA ID: RPAT211022151934 Ramp Type: Type 1 - Perpendicular Diagonal Initial Pass/Fail: Pass Overall Compliance: No Severity Score: 20

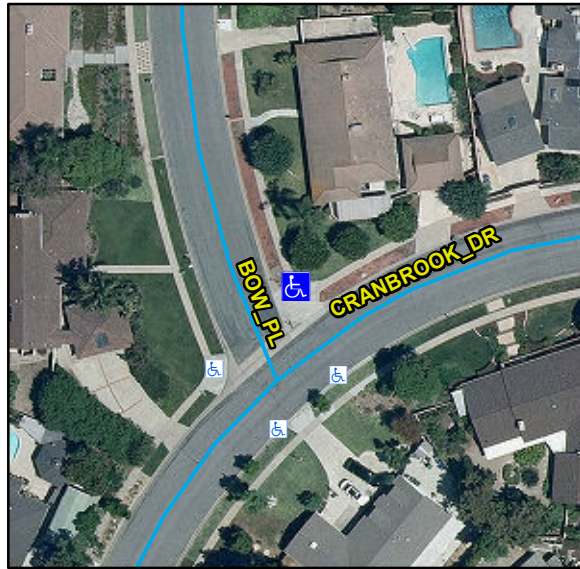
| Compliance | Description | Data | Compliance | Description | Data |
|---|---|---|---|---|---|
| No | Landing Width (in) | N/A | N/A | Flare Slope RT (%) | 3.4 |
| No | Landing Run Slope (%) | N/A | N/A | Flare Traversable RT | No |
| No | Landing Cross Slope (%) | N/A | No | DWS Provided | No |
| Yes | Gutter Ponding | No | No | Curb Slope | 8.4 |

Remove & Replace Curb Ramp With Two New Directional Ramps or Equivalent.

R304.2.2, R204.3, R304.2.1, R304.2.2-Perp, R304.3.2-Para, R304.5.3, R305, STD 1115
