# Access Compliance Report Public Rights-of-Way (Curb Ramps)

Main Street: BOW\_PL Cross Street: LASSEN\_DR Location: NE

ADA ID: RPAT211025092141 Ramp Type: Type 3 - Combination 1 Initial Pass/Fail: Fail Overall Compliance: No Severity Score: 5

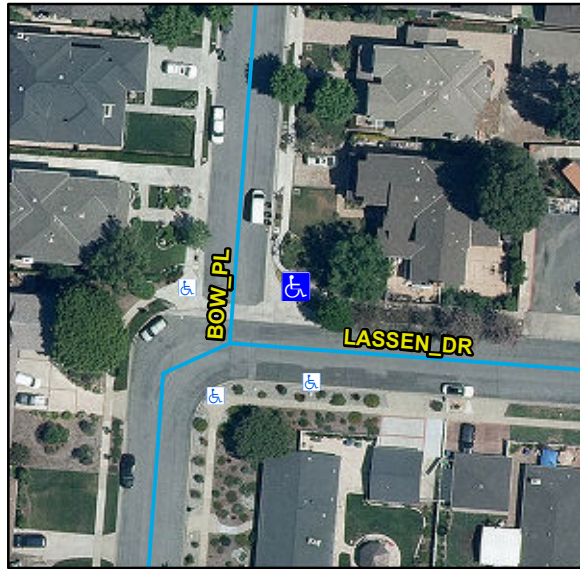
| Compliance | Description | Data | Compliance | Description | Data |
|---|---|---|---|---|---|
| No | Ramp Width LT (in) | 36 | Yes | Ramp Width RT (in) | 50 |
| No | Ramp Cross Slope LT (%) | 4.3 | Yes | Ramp Cross Slope RT (%) | 0.8 |

**Remove & Replace Curb Ramp With Two New Directional Ramps or Equivalent.**

**R304.5.1, R304.5.3, STD 1115**

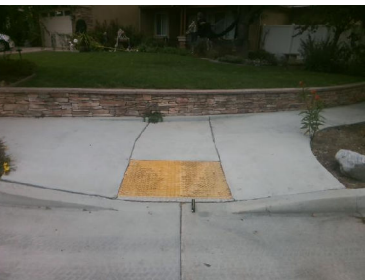
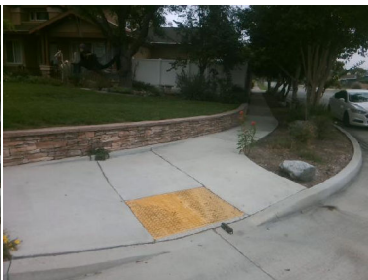
| Compliance | Description | Data | Compliance | Description | Data |
|---|---|---|---|---|---|
| Yes | Overall Surface Condition: Acceptable | | | | |
