# Access Compliance Report Public Rights-of-Way (Curb Ramps)

Main Street: BOW\_PL Cross Street: BOW\_PL Location: NW

ADA ID: RPAT211025092624 Ramp Type: Type 3 - Combination 1 Initial Pass/Fail: Fail Overall Compliance: No Severity Score: 2

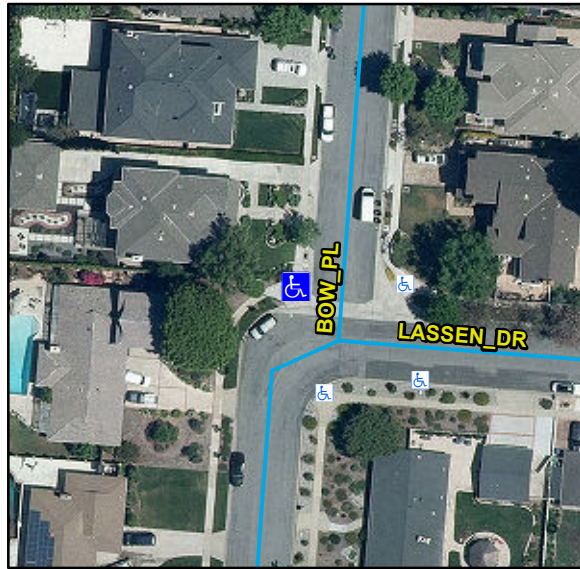
R304.2.2, R304.5.3, STD 1115

| Compliance | Description | Data | Compliance | Description | Data |
|---|---|---|---|---|---|
| No | Ramp Cross Slope (%) | 4.8 | N/A | Flare Traversable LT | N/A |

Remove & Replace Curb Ramp With Two New Directional Ramps or Equivalent.

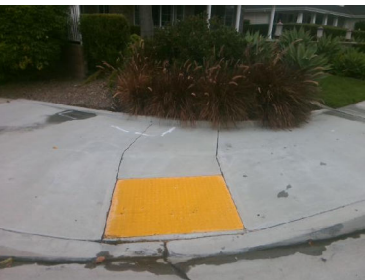
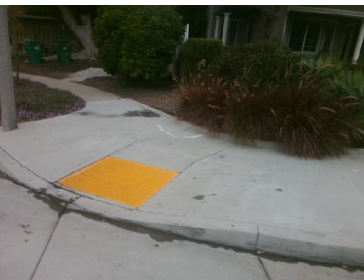
| Compliance | Description | Data | Compliance | Description | Data |
|---|---|---|---|---|---|
| Yes | Overall Surface Condition: Acceptable | | | | |
