# Access Compliance Report Public Rights-of-Way (Curb Ramps)

Main Street: ALLEGHENY\_DR Cross Street: BOW\_PL Location: NE

ADA ID: RPAT211025093318 Ramp Type: Type 6 - Directional 1 Initial Pass/Fail: Fail Overall Compliance: No Severity Score: 5

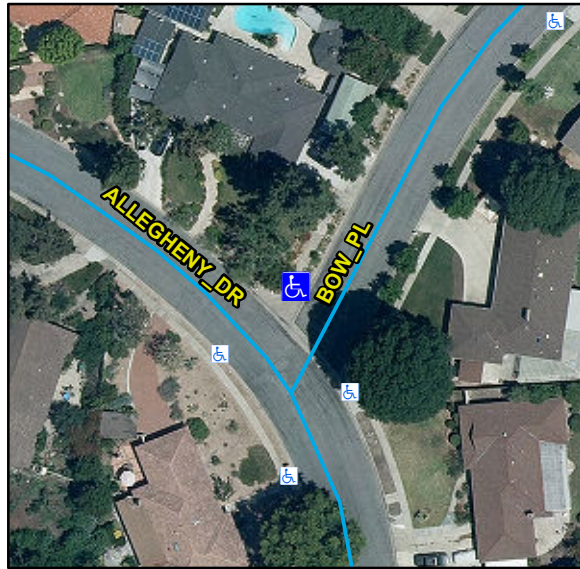
| Compliance | Description | Data | Compliance | Description | Data |
|---|---|---|---|---|---|
| No | Ramp Width (in) | 46 | | | N/A |
| No | Ramp Cross Slope (%) | 2.6 | N/A | Flare Traversable LT | N/A |

**Remove & Replace Curb Ramp With Two New Directional Ramps or Equivalent.**

**R204.3, R304.5.1, R304.5.3, STD 1115**

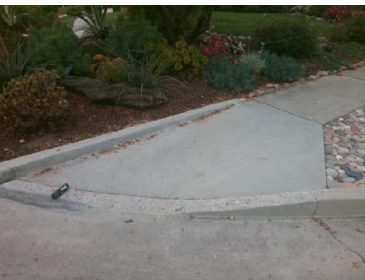
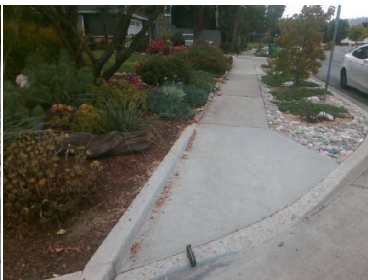
| Compliance | Description | Data | Compliance | Description | Data |
|---|---|---|---|---|---|
| Yes | Overall Surface Condition | Acceptable | No | Perp Joint Present | No |
