# Access Compliance Report Public Rights-of-Way (Curb Ramps)

Main Street: BOW\_PL Cross Street: BOW\_PL Location: SE

ADA ID: RPAT211025093543 Ramp Type: Type 1 - Perpendicular Diagonal Initial Pass/Fail: Pass Overall Compliance: No Severity Score: 20

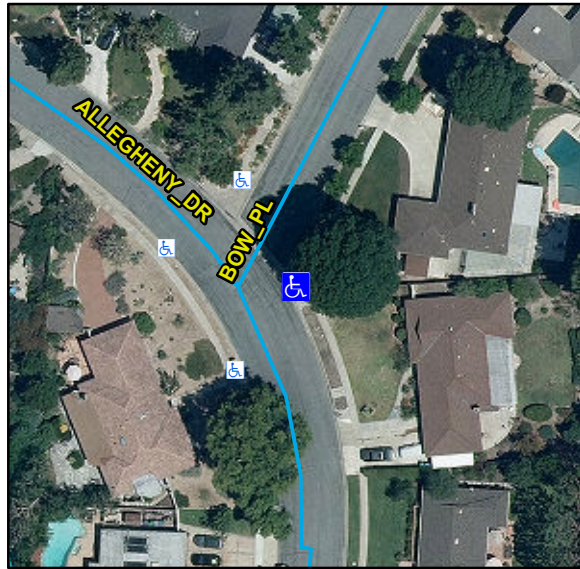
| Compliance | Description | Data | Compliance | Description | Data |
|---|---|---|---|---|---|
| N/A | Ramp Length (in) | 126 | N/A | Flare Type LT | |
| Yes | Ramp Width (in) | 64 | | | Sloped |
| Yes | Ramp Run Slope (%) | 6.9 | N/A | Flare Slope LT (%) | 5.9 |
| Yes | Ramp Cross Slope (%) | 1.3 | N/A | Flare Traversable LT | No |
| N/A | Landing Present | No | N/A | Flare Type RT | |
| No | Landing Width (in) | N/A | N/A | Flare Slope RT (%) | 3.5 |
| No | Landing Run Slope (%) | N/A | N/A | Flare Traversable RT | No |
| No | Landing Cross Slope (%) | N/A | No | DWS Provided | No |
| Yes | Gutter Ponding | No | No | Curb Slope | 11 |

Remove & Replace Curb Ramp With Two New Directional Ramps or Equivalent.

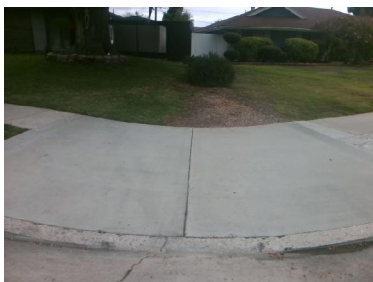
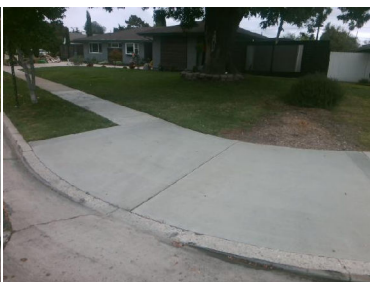
| Compliance | Description | Data | Compliance | Description | Data |
|---|---|---|---|---|---|
| Yes | Overall Surface Condition: Acceptable | | No | Perp Joint Present | No |
| | Cross Gutter Present? | Yes | | Spandrel Present? | Yes |
