# Access Compliance Report Public Rights-of-Way (Curb Ramps)

Main Street: MAUVE\_DR Cross Street: SHADEL\_DR Location: NE

ADA ID: RPAT211025094807 Ramp Type: Type 3 - Combination 1 Initial Pass/Fail: Fail Overall Compliance: No Severity Score: 20

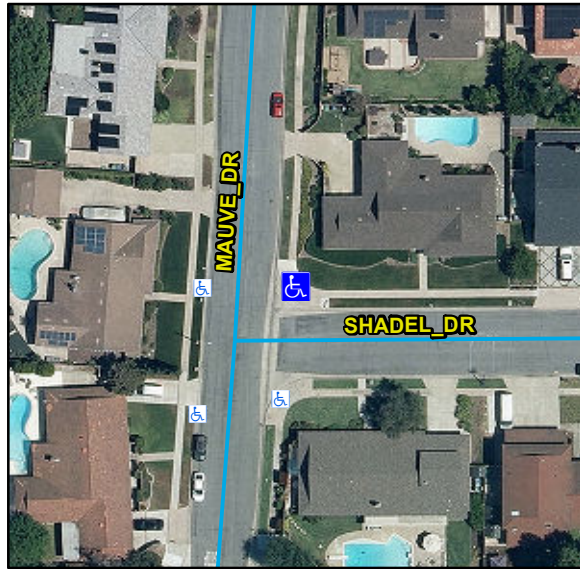
**R304.2.2, R204.3, R304.5.1, R304.5.3, R304.3.2, STD 1115**

| Compliance | Description | Data | Compliance | Description | Data |
|---|---|---|---|---|---|
| No | Ramp Width LT (in) | 38 | No | Ramp Width RT (in) | 40 |
| Yes | Ramp Run Slope LT (%) | 8.3 | No | Ramp Run Slope RT (%) | 8.5 |
| No | Ramp Cross Slope LT (%) | 4 | No | Ramp Cross Slope RT (%) | 2.6 |

**Remove & Replace Curb Ramp With Two New Directional Ramps or Equivalent.**

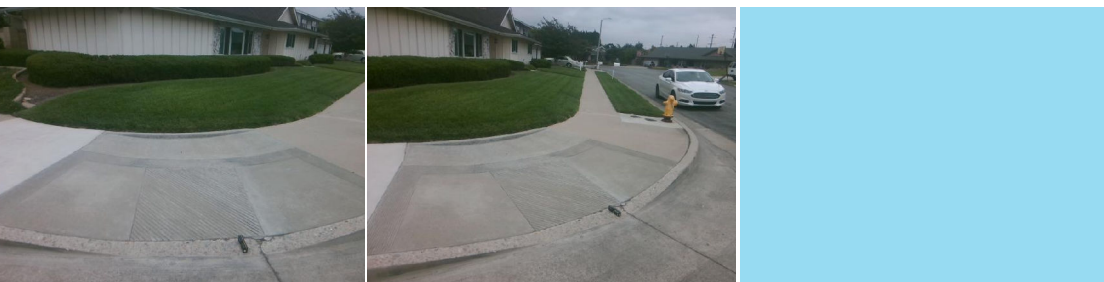
| Compliance | Description | Data | Compliance | Description | Data |
|---|---|---|---|---|---|
| N/A | Ramp Length LT (in) | 42 | N/A | Ramp Length RT (in) | 47 |
| N/A | Ramp Length (in) | 56 | N/A | Flare Type LT | |
| Yes | Ramp Width (in) | 48 | | | N/A |
| Yes | Ramp Run Slope (%) | 8.1 | N/A | Flare Slope LT (%) | N/A |
| Yes | Ramp Cross Slope (%) | 0.6 | N/A | Flare Traversable LT | N/A |
