# Access Compliance Report Public Rights-of-Way (Curb Ramps)

Main Street: SHADEL\_DR Cross Street: MAUVE\_DR Location: SE

ADA ID: RPAT211025095213 Ramp Type: Type 3 - Combination 1 Initial Pass/Fail: Fail Overall Compliance: No Severity Score: 5

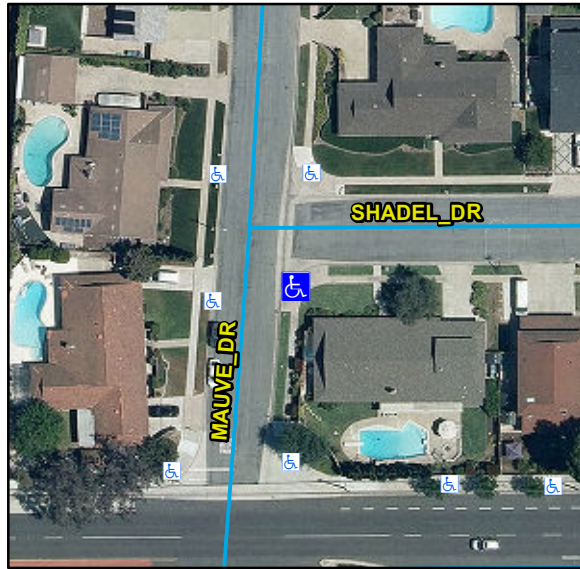
**R304.2.2, R204.3, R304.5.1, R304.5.3, STD 1115**

**Remove & Replace Curb Ramp With Two New Directional Ramps or Equivalent.**

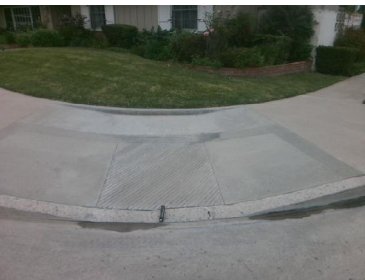
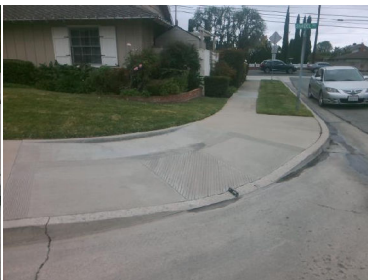
| Compliance | Description | Data | Compliance | Description | Data |
|---|---|---|---|---|---|
| No | Ramp Width LT (in) | 39 | No | Ramp Width RT (in) | 40 |
| No | Ramp Cross Slope LT (%) | 2.5 | Yes | Ramp Cross Slope RT (%) | 1.5 |
