# Access Compliance Report Public Rights-of-Way (Curb Ramps)

Main Street: LIMETREE\_WAY Cross Street: MAUVE\_DR Location: SE

ADA ID: RPAT211025095639 Ramp Type: Type 3 - Combination 1 Initial Pass/Fail: Fail Overall Compliance: No Severity Score: 4

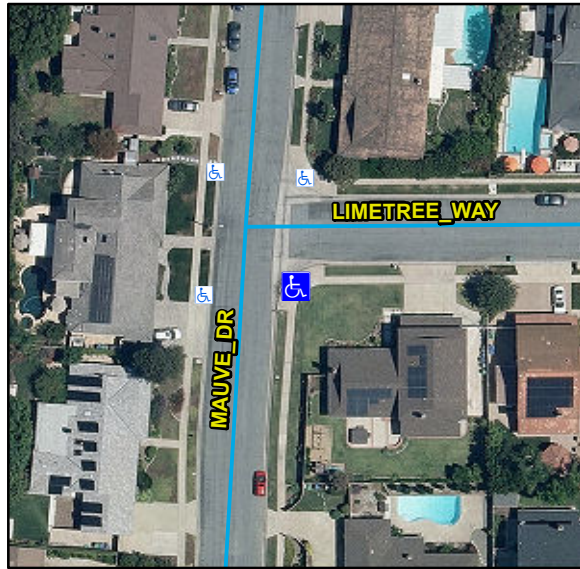
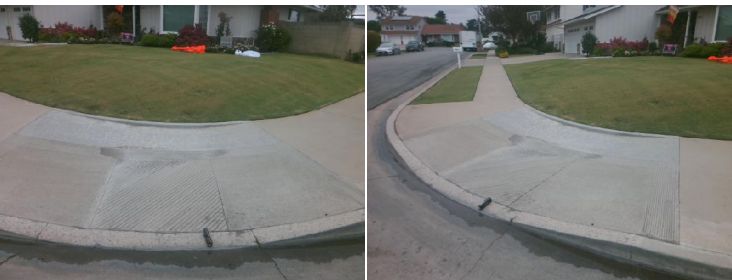
| Compliance | Description | Data | Compliance | Description | Data |
|---|---|---|---|---|---|
| No | Ramp Width LT (in) | 43 | No | Ramp Width RT (in) | 39 |
| No | Ramp Cross Slope LT (%) | 2.2 | Yes | Ramp Cross Slope RT (%) | 1.6 |
| N/A | Gutter Ponding | N/A | No | Curb Slope | 9.3 |

**Remove & Replace Curb Ramp With Two New Directional Ramps or Equivalent.**

**R304.2.2, R204.3, R304.5.1, R304.5.3, STD 1115**
