# Access Compliance Report Public Rights-of-Way (Curb Ramps)

Main Street: MAUVE\_DR Cross Street: LIMETREE\_WAY Location: NE

ADA ID: RPAT211025095929 Ramp Type: Type 3 - Combination 1 Initial Pass/Fail: Fail Overall Compliance: No Severity Score: 5

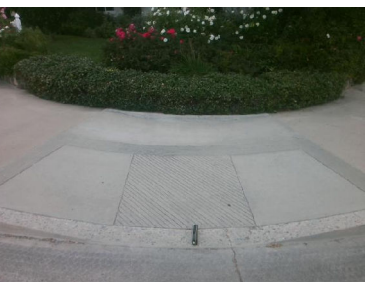
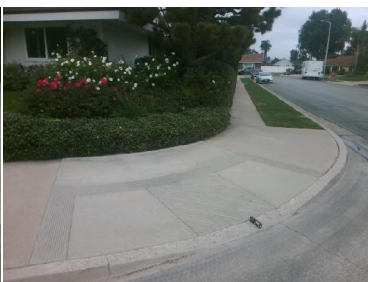
| Compliance | Description | Data | Compliance | Description | Data |
|---|---|---|---|---|---|
| No | Ramp Width LT (in) | 41 | No | Ramp Width RT (in) | 40 |
| No | Ramp Cross Slope LT (%) | 2.9 | No | Ramp Cross Slope RT (%) | 2.4 |

Remove & Replace Curb Ramp With Two New Directional Ramps or Equivalent. Remove & Replace Sidewalk.
