# Access Compliance Report Public Rights-of-Way (Curb Ramps)

Main Street: GRAMERCY\_DR Cross Street: GERSHON\_PL Location: SE

ADA ID: RPAT211025113128 Ramp Type: Type 1 - Perpendicular Diagonal Initial Pass/Fail: Pass Overall Compliance: No Severity Score: 26

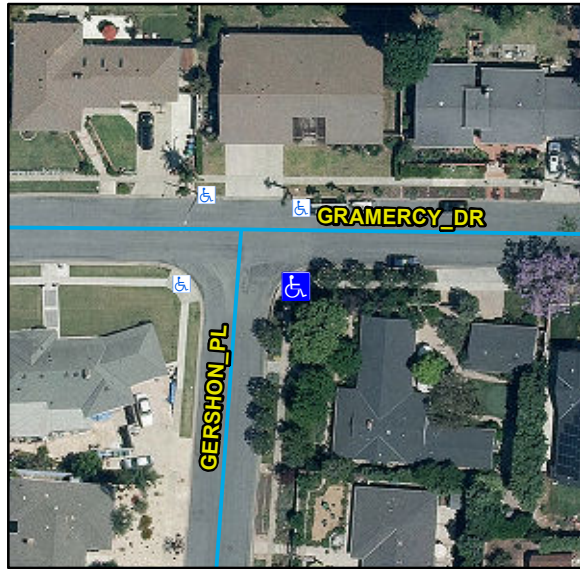
| Compliance | Description | Data | Compliance | Description | Data |
|---|---|---|---|---|---|
| No | Landing Width (in) | N/A | N/A | Flare Slope RT (%) | 5.5 |
| No | Landing Run Slope (%) | N/A | N/A | Flare Traversable RT | No |
| No | Landing Cross Slope (%) | N/A | No | DWS Provided | No |
| No | Gutter Run Slope (%) | 5.1 | | Road Cross Slope (%) | 2.6 |

Remove & Replace Curb Ramp With Two New Directional Ramps or Equivalent. Remove & Replace Gutter.
