# Access Compliance Report Public Rights-of-Way (Curb Ramps)

Main Street: GRAMERCY\_DR Cross Street: ESPLANADE\_AVE Location: SW

ADA ID: RPAT211025114936 Ramp Type: Type 4 - Parallel Initial Pass/Fail: Fail Overall Compliance: No Severity Score: 2

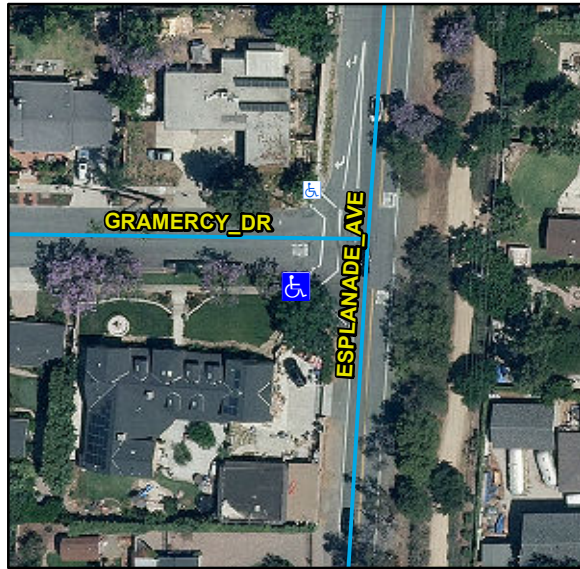
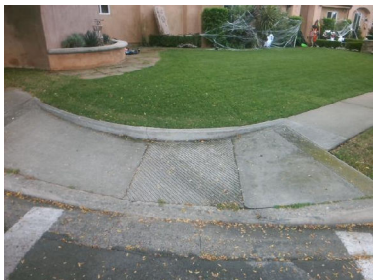
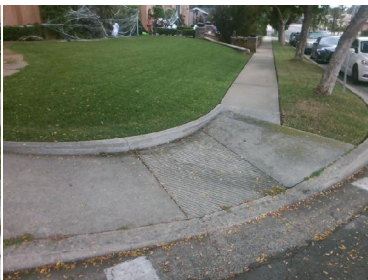
| Compliance | Description | Data | Compliance | Description | Data |
|---|---|---|---|---|---|
| No | Ramp Cross Slope LT (%) | 3.5 | Yes | Ramp Cross Slope RT (%) | 0.1 |

Remove & Replace Entire Ramp.

R304.5.3, STD 1115
