# Access Compliance Report Public Rights-of-Way (Curb Ramps)

Main Street: GRAMERCY\_DR Cross Street: ESPLANADE\_AVE Location: NW

ADA ID: RPAT211025115200 Ramp Type: Type 4 - Parallel Initial Pass/Fail: Fail Overall Compliance: No Severity Score: 15

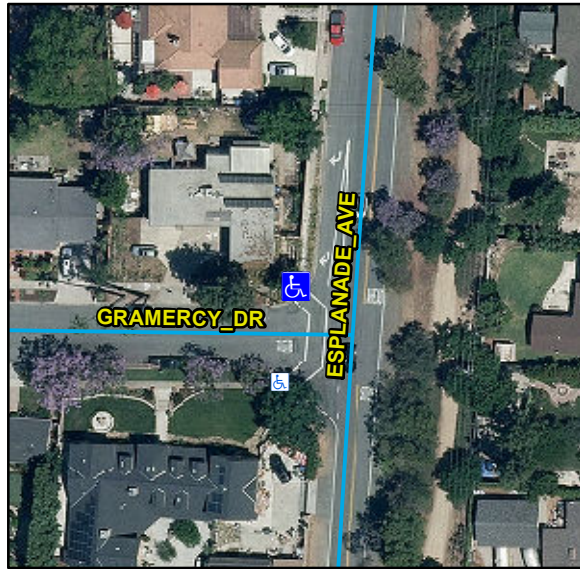
| Compliance | Description | Data | Compliance | Description | Data |
|---|---|---|---|---|---|
| No | Ramp Run Slope LT (%) | 9 | Yes | Ramp Run Slope RT (%) | 8.2 |

Remove & Replace Entire Ramp.

R304.3.2, STD 1115
