# Access Compliance Report Public Rights-of-Way (Curb Ramps)

Main Street: EHLEN\_WAY Cross Street: VERA\_ST Location: SE

ADA ID: RPAT211025122205 Ramp Type: Type 1 - Perpendicular Diagonal Initial Pass/Fail: Pass Overall Compliance: No Severity Score: 10

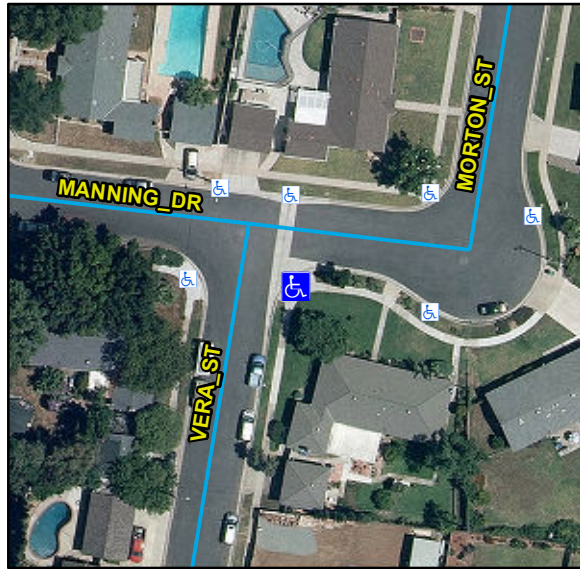
| Compliance | Description | Data | Compliance | Description | Data |
|---|---|---|---|---|---|
| Yes | Landing Cross Slope (%) | 0.5 | No | DWS Provided | No |
| Yes | Gutter Ponding | No | No | Curb Slope | 9.1 |

Remove & Replace Curb Ramp With Two New Directional Ramps or Equivalent.

R304.2.2, R304.2.1, R305, STD 1115
