# Access Compliance Report Public Rights-of-Way (Curb Ramps)

Main Street: VERA\_ST Cross Street: MANNING\_DR Location: SW

ADA ID: RPAT211025122602 Ramp Type: Type 1 - Perpendicular Diagonal Initial Pass/Fail: Fail Overall Compliance: No Severity Score: 15

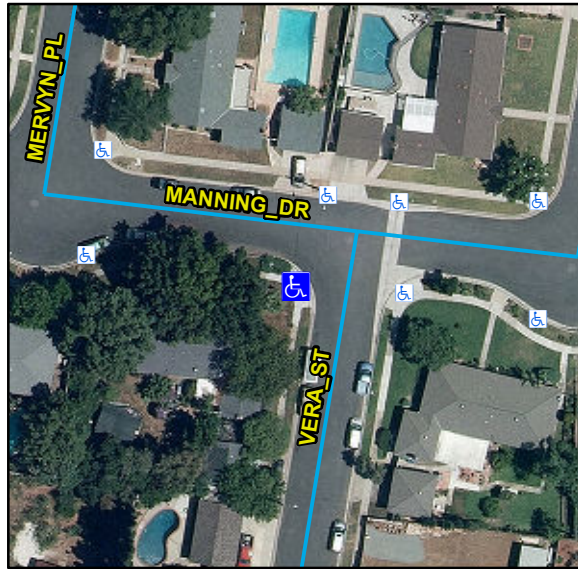
| Compliance | Description | Data | Compliance | Description | Data |
|---|---|---|---|---|---|
| No | Ramp Run Slope (%) | 8.5 | N/A | Flare Slope LT (%) | N/A |

Remove & Replace Curb Ramp With Two New Directional Ramps or Equivalent.

R304.2.2, STD 1115

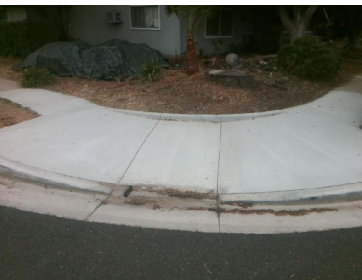
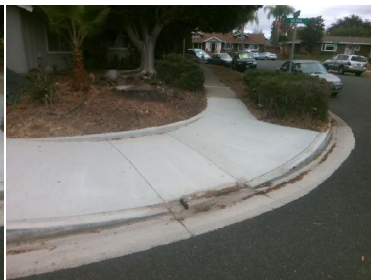
| Compliance | Description | Data | Compliance | Description | Data |
|---|---|---|---|---|---|
| Yes | Overall Surface Condition: Acceptable | | Yes | Perp Joint Present | Yes |
