# Access Compliance Report Public Rights-of-Way (Curb Ramps)

Main Street: KOOTENAY\_DR Cross Street: OAK\_RIDGE\_DR Location: NE

ADA ID: RPAT211026093346 Ramp Type: Type 6 - Directional 1 Initial Pass/Fail: Fail Overall Compliance: No Severity Score: 5

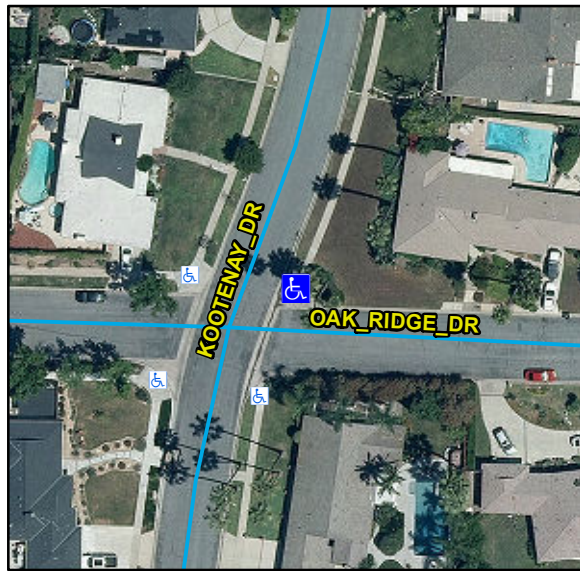
| Compliance | Description | Data | Compliance | Description | Data |
|---|---|---|---|---|---|
| No | Ramp Width (in) | 44 | | | N/A |
| No | Ramp Cross Slope (%) | 4 | N/A | Flare Traversable LT | N/A |

**Remove & Replace Curb Ramp With Two New Directional Ramps or Equivalent.**

**R204.3, R304.5.1, R304.5.3, STD 1115**
