# Access Compliance Report Public Rights-of-Way (Curb Ramps)

Main Street: OAK RIDGE\_DR Cross Street: KOOTENAY\_DR Location: NW

ADA ID: RPAT211026093619 Ramp Type: Type 1 - Perpendicular Diagonal Initial Pass/Fail: Pass Overall Compliance: No Severity Score: 20

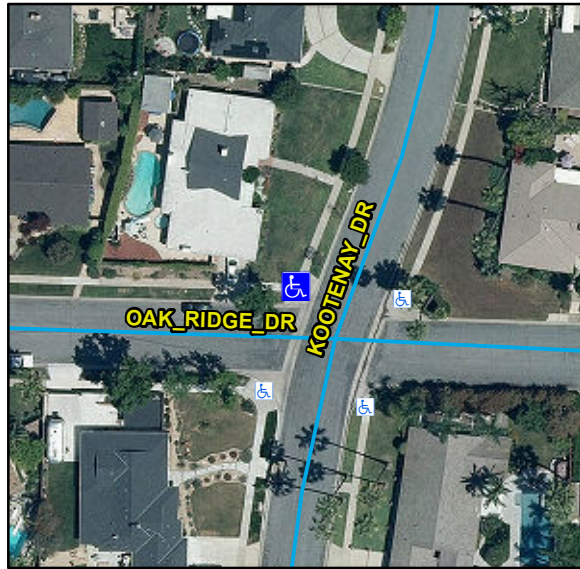
| Compliance | Description | Data | Compliance | Description | Data |
|---|---|---|---|---|---|
| No | Landing Width (in) | N/A | N/A | Flare Slope RT (%) | 5.6 |
| No | Landing Run Slope (%) | N/A | N/A | Flare Traversable RT | No |
| No | Landing Cross Slope (%) | N/A | No | DWS Provided | No |

Remove & Replace Curb Ramp With Two New Directional Ramps or Equivalent.

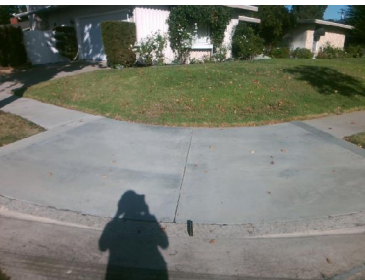
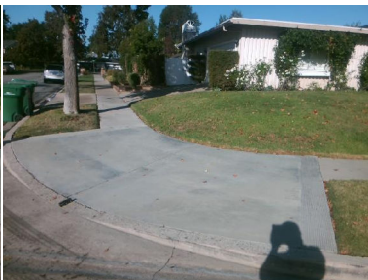
| Compliance | Description | Data | Compliance | Description | Data |
|---|---|---|---|---|---|
| Yes | Overall Surface Condition: Acceptable | | No | Perp Joint Present | No |
