# Access Compliance Report Public Rights-of-Way (Curb Ramps)

Main Street: KOOTENAY\_DR Cross Street: OAK\_RIDGE\_DR Location: SW

ADA ID: RPAT211026093920 Ramp Type: Type 1 - Perpendicular Diagonal Initial Pass/Fail: Pass Overall Compliance: No Severity Score: 22

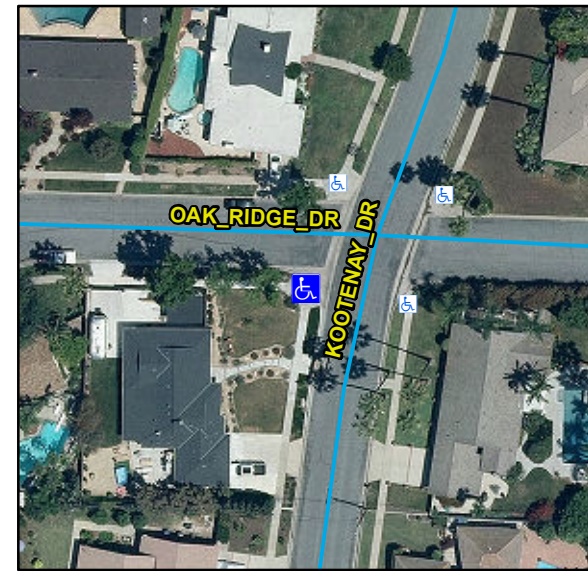
| Compliance | Description | Data | Compliance | Description | Data |
|---|---|---|---|---|---|
| No | Landing Width (in) | N/A | N/A | Flare Slope RT (%) | 8.3 |
| No | Landing Run Slope (%) | N/A | N/A | Flare Traversable RT | No |
| No | Landing Cross Slope (%) | N/A | No | DWS Provided | No |
| No | Gutter Cross Slope (%) | 2.4 | | | |

Possible Solutions:  
**Remove & Replace Curb Ramp With Two New Directional Ramps or Equivalent. Remove & Replace Gutter.**
