# Access Compliance Report Public Rights-of-Way (Curb Ramps)

| Main Street: OAK RIDGE_DR | | Cross Street: KOOTENAY_DR | | Location: | SE |
| ADA ID: RPAT211026094149 | Ramp Type: Type 6 - Directional 1 | Initial Pass/Fail: Fail | Overall Compliance: No | Severity Score: | 34 |

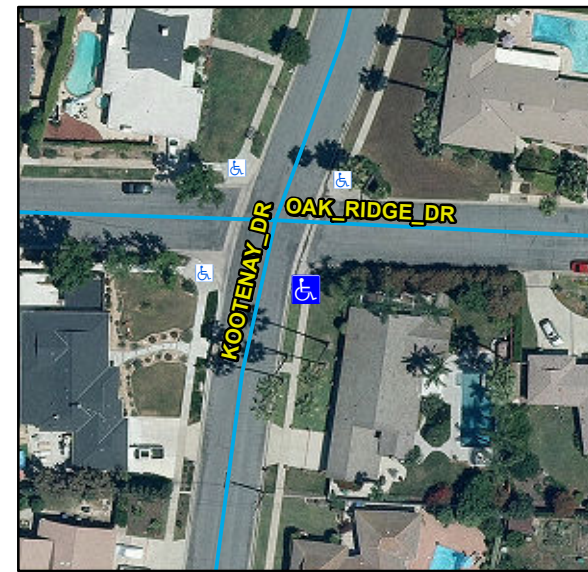
| Compliance | Description | Data | Compliance | Description | Data |
|---|---|---|---|---|---|
| No | Ramp Width (in) | 46 | | | N/A |
| No | Ramp Cross Slope (%) | 8.1 | N/A | Flare Traversable LT | N/A |

**Remove & Replace Curb Ramp With Two New Directional Ramps or Equivalent.**

**R204.3, R304.5.1, R304.5.3, STD 1115**

Total Cost: \$ 3080

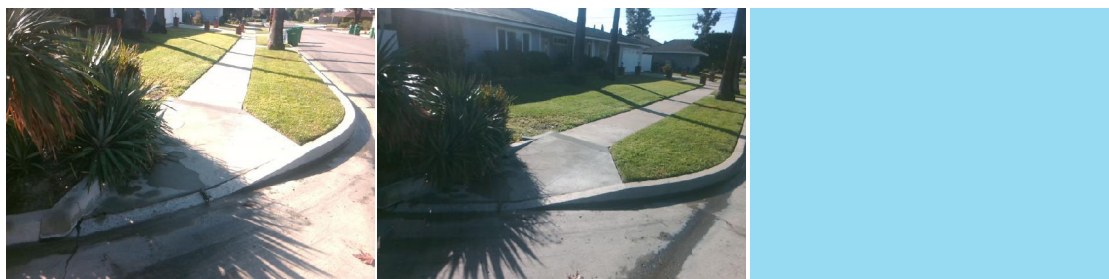
| Compliance | Description | Data | Compliance | Description | Data |
|---|---|---|---|---|---|
| N/A | Ramp Length (in) | 99 | N/A | Flare Type LT | |
| Yes | Ramp Run Slope (%) | 7 | N/A | Flare Slope LT (%) | N/A |
