# Access Compliance Report Public Rights-of-Way (Curb Ramps)

Main Street: KOOTENAY\_DR Cross Street: SANTA\_CLARA\_AVE Location: NE

ADA ID: RPAT211026094455 Ramp Type: Type 1 - Perpendicular Diagonal Initial Pass/Fail: Pass Overall Compliance: No Severity Score: 0

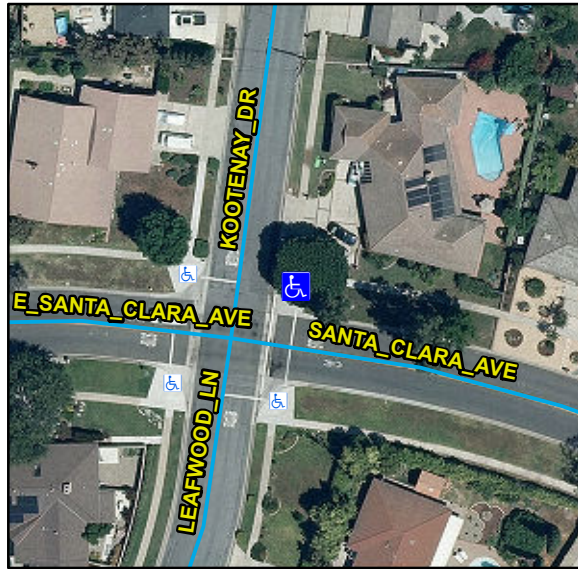
| Compliance | Description | Data | Compliance | Description | Data |
|---|---|---|---|---|---|
| No | Landing Run Slope (%) | 4.2 | N/A | Flare Traversable RT | No |
| Yes | Gutter Ponding | No | No | Curb Slope | 9.1 |

Remove & Replace Curb Ramp With Two New Directional Ramps or Equivalent.
