# Access Compliance Report Public Rights-of-Way (Curb Ramps)

Main Street: E\_SANTA\_CLARA\_AVE Cross Street: KOOTENAY\_DR Location: NW

ADA ID: RPAT211026094848 Ramp Type: Type 1 - Perpendicular Diagonal Initial Pass/Fail: Pass Overall Compliance: No Severity Score: 0

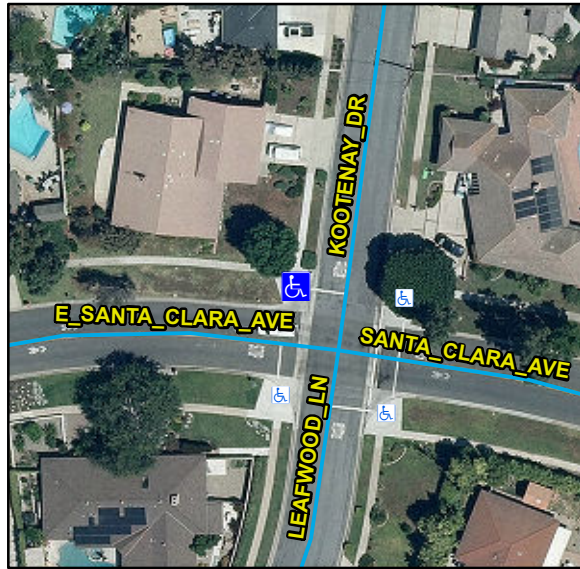
| Compliance | Description | Data | Compliance | Description | Data |
|---|---|---|---|---|---|
| No | Landing Cross Slope (%) | 2.3 | Yes | DWS Provided | Yes |
| No | Gutter Ponding | Yes | No | Curb Slope | 7.7 |

Remove & Replace Curb Ramp With Two New Directional Ramps or Equivalent.

R304.2.2, R304.5.3, R302.7, STD 1115
