# Access Compliance Report Public Rights-of-Way (Curb Ramps)

Main Street: SANTA\_CLARA\_AVE Cross Street: LEAFWOOD\_LN Location: SE

ADA ID: RPAT211026095630 Ramp Type: Type 1 - Perpendicular Diagonal Initial Pass/Fail: Fail Overall Compliance: No Severity Score: 2

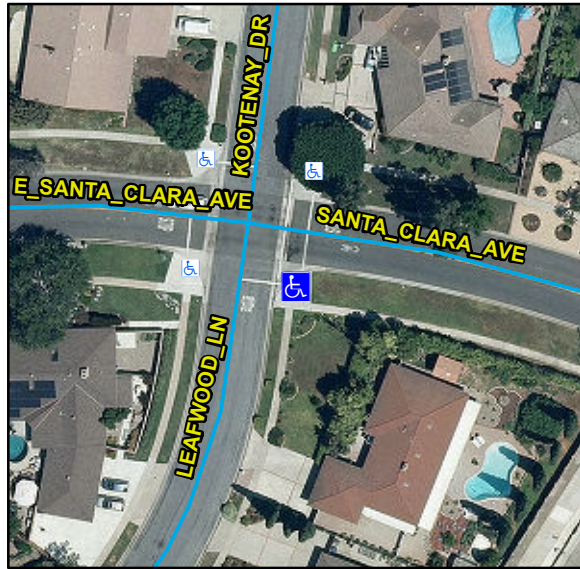
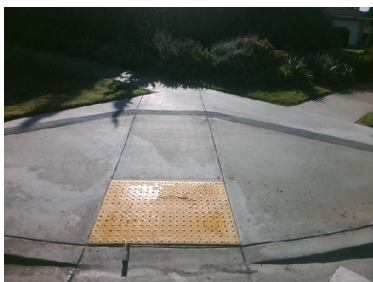
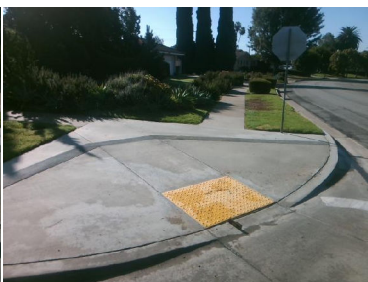
| Compliance | Description | Data | Compliance | Description | Data |
|---|---|---|---|---|---|
| No | Ramp Cross Slope (%) | 2.7 | N/A | Flare Traversable LT | N/A |

Remove & Replace Curb Ramp With Two New Directional Ramps or Equivalent.

R304.2.2, R304.5.3, STD 1115
