# Access Compliance Report Public Rights-of-Way (Curb Ramps)

Main Street: GERSHON\_PL Cross Street: SANTA\_CLARA\_AVE Location: W

ADA ID: RPAT211026101150 Ramp Type: Type 1 - Perpendicular Diagonal Initial Pass/Fail: Pass Overall Compliance: No Severity Score: 4

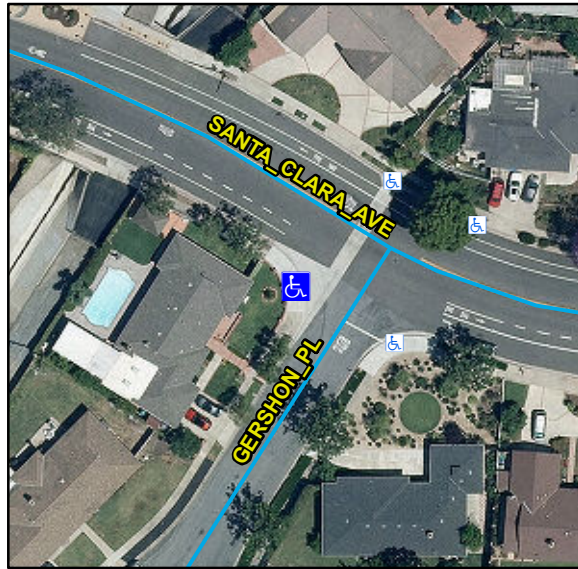
| Compliance | Description | Data | Compliance | Description | Data |
|---|---|---|---|---|---|
| Yes | Gutter Ponding | No | No | Curb Slope | 12.8 |

Remove & Replace Curb Ramp With Two New Directional Ramps or Equivalent.

R304.2.2, R304.2.1, STD 1115
