# Access Compliance Report Public Rights-of-Way (Curb Ramps)

Main Street: SANTA\_CLARA\_AVE Cross Street: GERSHON\_PL Location: SE

ADA ID: RPAT211026101907 Ramp Type: Type 1 - Perpendicular Diagonal Initial Pass/Fail: Fail Overall Compliance: No Severity Score: 16

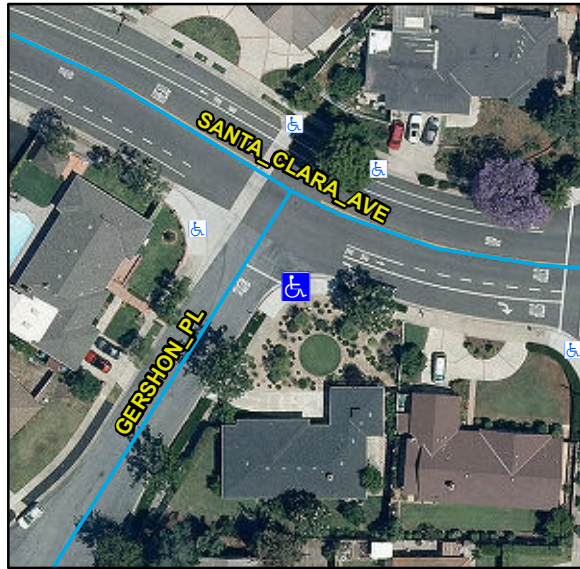
| Compliance | Description | Data | Compliance | Description | Data |
|---|---|---|---|---|---|
| No | Ramp Run Slope (%) | 8.6 | N/A | Flare Slope LT (%) | N/A |
| No | Ramp Cross Slope (%) | 3.5 | N/A | Flare Traversable LT | N/A |

Remove & Replace Curb Ramp With Two New Directional Ramps or Equivalent.
