# Access Compliance Report Public Rights-of-Way (Curb Ramps)

Main Street: ESPLANADE\_AVE Cross Street: SANTA\_CLARA\_AVE Location: SW

ADA ID: RPAT211026102342 Ramp Type: Type 1 - Perpendicular Diagonal Initial Pass/Fail: Fail Overall Compliance: No Severity Score: 2

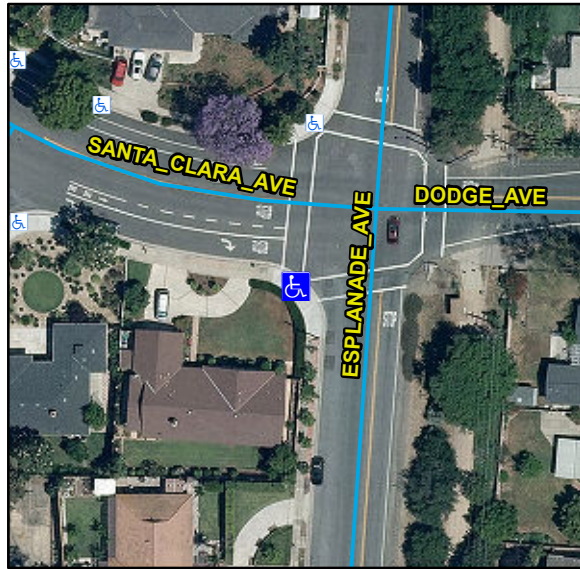
| Compliance | Description | Data | Compliance | Description | Data |
|---|---|---|---|---|---|
| No | Ramp Cross Slope (%) | 2.7 | N/A | Flare Traversable LT | N/A |

Remove & Replace Curb Ramp With Two New Directional Ramps or Equivalent.

R304.2.2, R304.5.3, STD 1115
