# Access Compliance Report Public Rights-of-Way (Curb Ramps)

Main Street: SANTA\_CLARA\_AVE Cross Street: ESPLANADE\_AVE Location: NW

ADA ID: RPAT211026102612 Ramp Type: Type 1 - Perpendicular Diagonal Initial Pass/Fail: Fail Overall Compliance: No Severity Score: 2

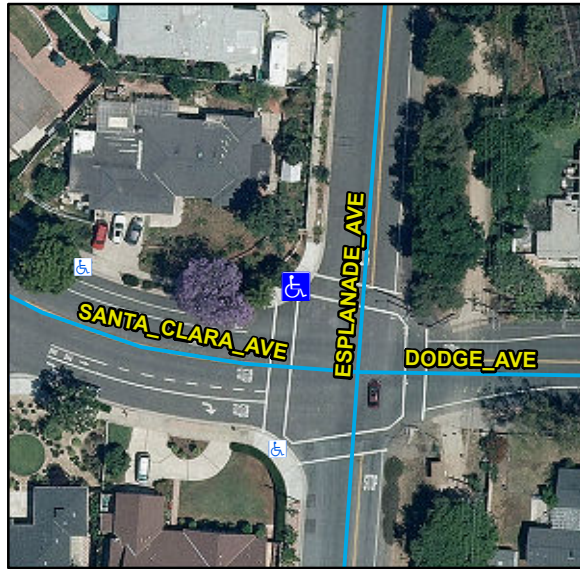
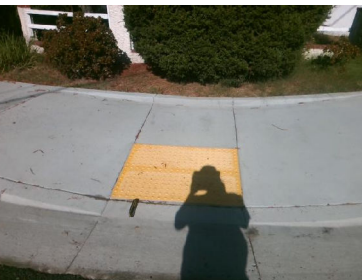
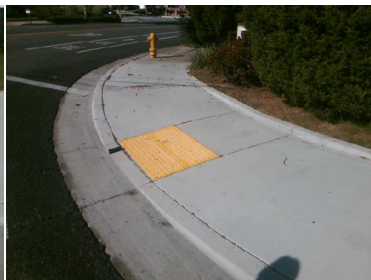
R304.2.2, R304.5.3, STD 1115

| Compliance | Description | Data | Compliance | Description | Data |
|---|---|---|---|---|---|
| No | Ramp Cross Slope (%) | 3.2 | N/A | Flare Traversable LT | N/A |

Remove & Replace Curb Ramp With Two New Directional Ramps or Equivalent.
