# Access Compliance Report Public Rights-of-Way (Curb Ramps)

| Main Street: SAUGUS_AVE | | Cross Street: WINTHROPE_ST | | Location: | NW |
| ADA ID: RPAT211026124350 | Ramp Type: Type 4 - Parallel | Initial Pass/Fail: Pass | Overall Compliance: No | Severity Score: | 12 |

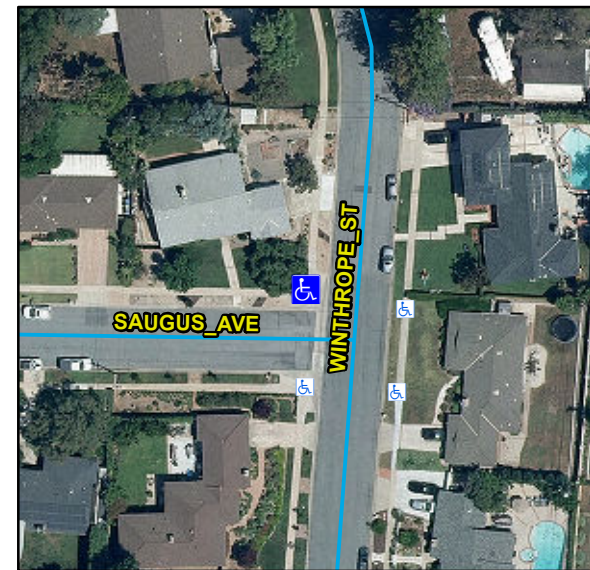
| Compliance | Description | Data | Compliance | Description | Data |
|---|---|---|---|---|---|
| Yes | Ramp Cross Slope LT (%) | 1.9 | No | Ramp Cross Slope RT (%) | 2.6 |
| N/A | Landing Present | Yes | No | DWS Provided | No |
| No | Landing Run Slope (%) | 2.5 | N/A | DWS Full Width | N/A |

**Remove & Replace Curb Ramp With Two New Directional Ramps or Equivalent.**

**R204.3, R304.5.3, R304.2.2-Perp, R304.3.2-Para, R305, STD 1115**
