# Access Compliance Report Public Rights-of-Way (Curb Ramps)

| Main Street: WINTHROPE_ST | | Cross Street: SAUGUS_AVE | | Location: | SW |
| ADA ID: RPAT211026125132 | Ramp Type: Type 4 - Parallel | Initial Pass/Fail: Pass | Overall Compliance: No | Severity Score: | 0 |

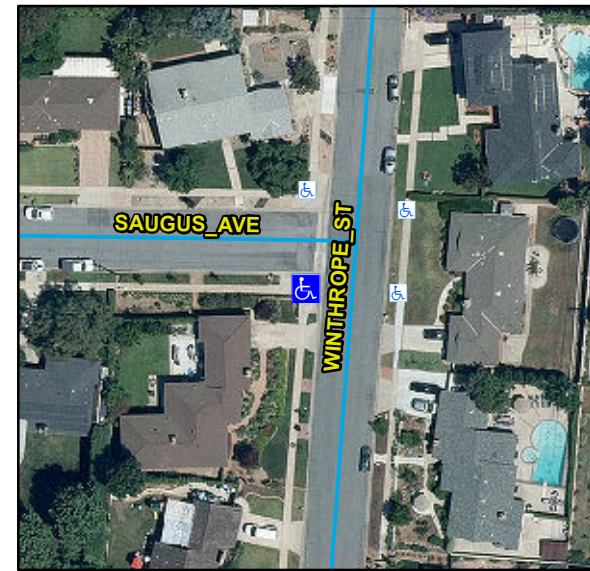
Surveyor Notes:

N/A

Possible Solutions:

**Remove & Replace Curb Ramp With Two New Directional Ramps or Equivalent.**

OC Std/PROW:

**R204.3, STD 1115**

Total Cost: \$ 4000
