# Access Compliance Report Public Rights-of-Way (Curb Ramps)

Main Street: WINTHROPE\_ST Cross Street: ERVIN\_LN Location: NE

ADA ID: RPAT211026125913 Ramp Type: Type 4 - Parallel Initial Pass/Fail: Pass Overall Compliance: No Severity Score: 12

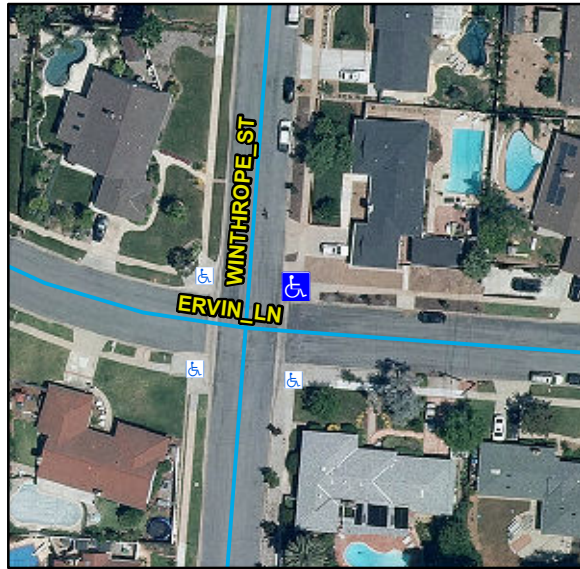
| Compliance | Description | Data | Compliance | Description | Data |
|---|---|---|---|---|---|
| N/A | Landing Present | Yes | No | DWS Provided | No |
| No | Landing Cross Slope (%) | 2.2 | | DWS Offset Type | N/A |

Remove & Replace Curb Ramp With Two New Directional Ramps or Equivalent.

R204.3, R304.5.3, R305, STD 1115
